Transformer Remanufacturing and Engineering Services (TRES) Load tap changer retrofit kit solves recurrent problems

When an Allis Chalmers TLH21 load tap changer (LTC) had recurrent problems, ABB TRES was able to get to the root cause and deliver a solution.

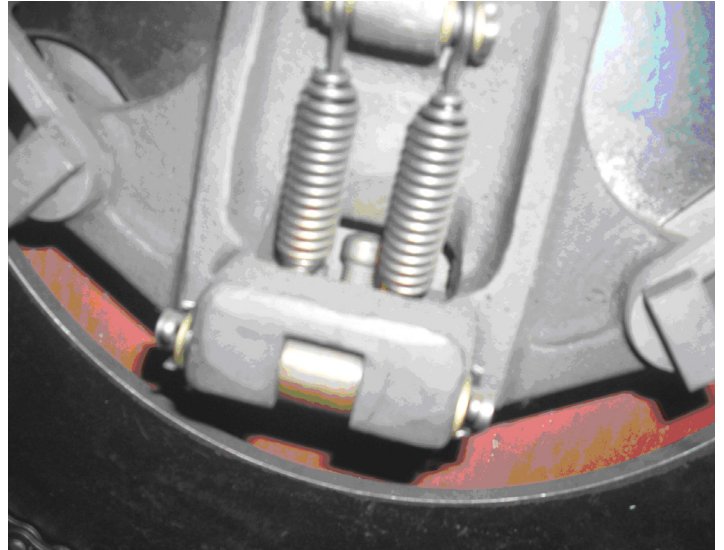
All the moving contacts and some stationary contacts on an LTC needed replacement every six months. However, when the customer changed these contacts every six months, they were treating a symptom of the problem, not the cause. The contacts would burn because the LTC did not stop on position, resulting in incomplete electrical contact and excessive heating. This was happening because the accelerator latch assembly was malfunctioning. The stop latch mechanism pin, which is part of the accelerating latch assembly, is supposed to control the movement of the gears by fitting between the teeth of the LTC gears, thereby stopping the gears at the correct position. In this case, however, the stop pin was bent so it didn't fit between the gears and couldn't control them. So when the pin got the impulse to let the gears move, it would let the gears overrun. This resulted in misalignment of the contacts, incomplete electrical contact, heating and burning of the contacts.

LTC accelerating latch assembly

When the ABB TRES LTC specialists arrived on the customer site, the LTC was mechanically jammed. They disassembled the LTC, diagnosed the problem then explained that the latch mechanism stop pin had bent because it had been used for over 129,000 operations.

The ABB TRES team replaced the bent pin, but they did not stop there. The reversing switch and phase panels were scorched from all the excessive heating. The ABB TRES LTC specialists, therefore, installed a new ABB LTC Retrofit Kit that consists of all new moving contacts, stationary contacts and reversing switch as well as all new phase panels.
