## Optimized use of HV composite apparatus insulators: field experience from coastal and inland test stations

**I. Gutman\***  
**STRI**

**L. Stenström, D. Gustavsson, D. Windmar**  
**ABB Power Technologies**

**W.L. Vosloo**  
**ESKOM**

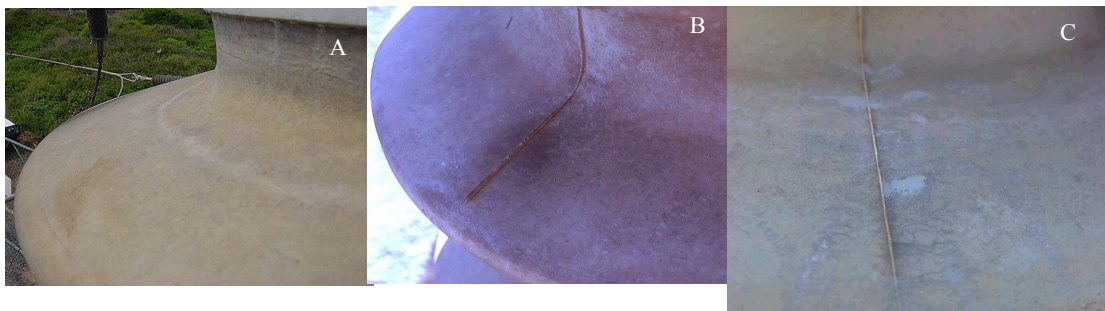
Figure 2 Kelso, apparatus insulators. Examples of deterioration: A: bushing-23, whitish rings; B: arrester-12, dark pattern; C: arrester-16, traces of discharge activity.

At the most polluted coastal test sites, i.e. Dungeness and Kelso no deterioration except colour changes due to discharge activity (whitish and dark patterns most likely due to water dripping from the upper sheds), traces of discharge activity and slight erosion has been observed on apparatus insulators during the field tests. The details are shown in Figure 1 and Figure 2. No deterioration at all has been observed at the clean site in Sweden and at the desert site in Israel.

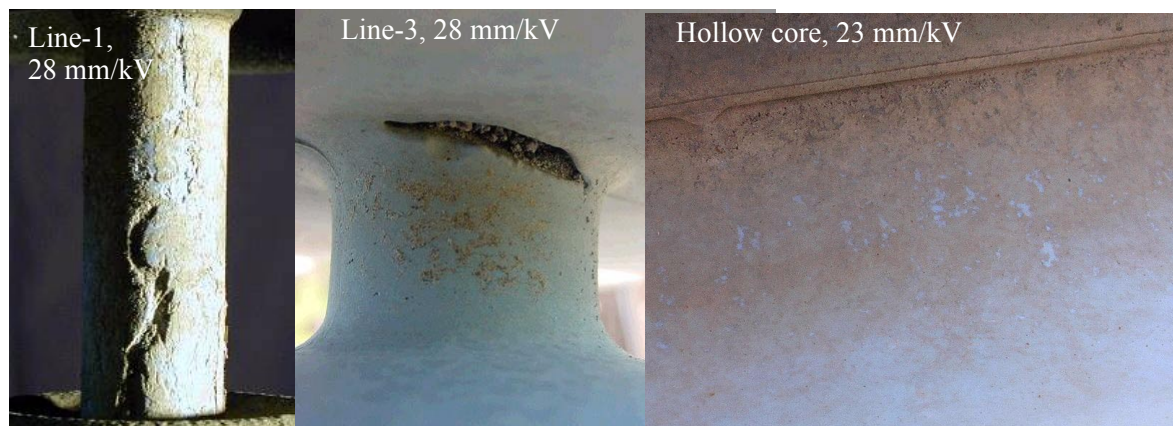
Figure 4 Kelso. Deterioration: comparison of line and hollow insulators.

At the same time 15 composite line insulators were installed at the two test sites, i.e. Dungeness and Kelso. These results were partially reported in [2]. They were also complemented by one hollow insulator at each site delivered by the same manufacturer as one of the line insulators. A summary on all tested line composite (and one hollow) insulators and their exposure time is presented in Table 3 together with the description of their deterioration. Examples of deterioration/damages with some comments are shown in Figure 3 and Figure 4.

Test station	Type of insulator	Specific creepage, mm/kV	Exposure time, years	Type of deterioration
Dungeness	Line-1	18; 23; 23	5,5	Erosion
	Line-2	25	6	Erosion
	Line-3	22; 22	6	Erosion
	Hollow	21	7	Slight erosion
Kelso	Line-1	18; 23; 28; 29	4,5	Erosion
	Line-2	28	6,5	Erosion
	Line-3	22; 28; 28; 33	6,5 <sup>a</sup>	Erosion
	Hollow	23	6,5	Start of erosion

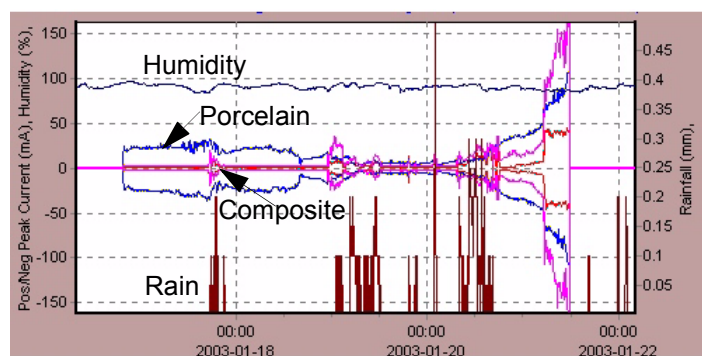
Figure 6 Example of typical pollution event at Dungeness.

Due to the physics of the pollution event, typically, peak currents can be related to the pollution performance of an insulator. In general, a high leakage current indicates a high probability for flashover, as the partial surface discharges (arcs) over the dry bands have a greater possibility to elongate and to bridge the whole insulator. A pollution event is thus defined as the time when the leakage current pulses exceeds a certain value. Preliminary analysis showed that the Dungeness test station is the worst for the insulators from pollution point of view. Severe storms followed by long periods of high humidity and light rain are worse than more moderate breeze type winds at Kelso followed by powerful subtropical rains, see maximum rain conditions in Table 1. Therefore, typical difference in silicone rubber/porcelain performance during pollution event is presented only for the Dungeness test station. Three test objects with similar creepage distance are chosen for the analysis, i.e. arrester-31 mm/kV; bushing-32 and porcelain hollow-32. In Figure 6 the peak currents (measured at 2 kHz and stored every 10 min.) are presented vs relative humidity and rain.

High currents on porcelain insulator typically started earlier during the storm than on silicone rubber insulators. This behaviour correlates well with worse hydrophobicity (higher HC) of porcelain, see Figure 5. More moisture in the form of light rain is also needed to produce high currents on silicone rubber insulators. In a short run, at some moment during the storm, the peak currents on silicone rubber insulators can exceed those on porcelain. However, in long-term one can expect that the porcelain insulator will have a larger number of high leakage current pulses than silicone rubber insulator. This

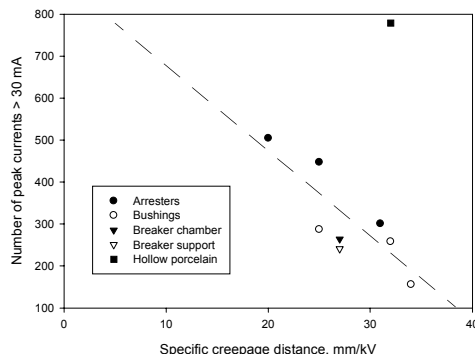
Figure 8 Dungeness: Correlation between the average number of peak currents over 30 mA during the storms 2002-2003 and specific creepage distance for silicone rubber and porcelain apparatus insulators.

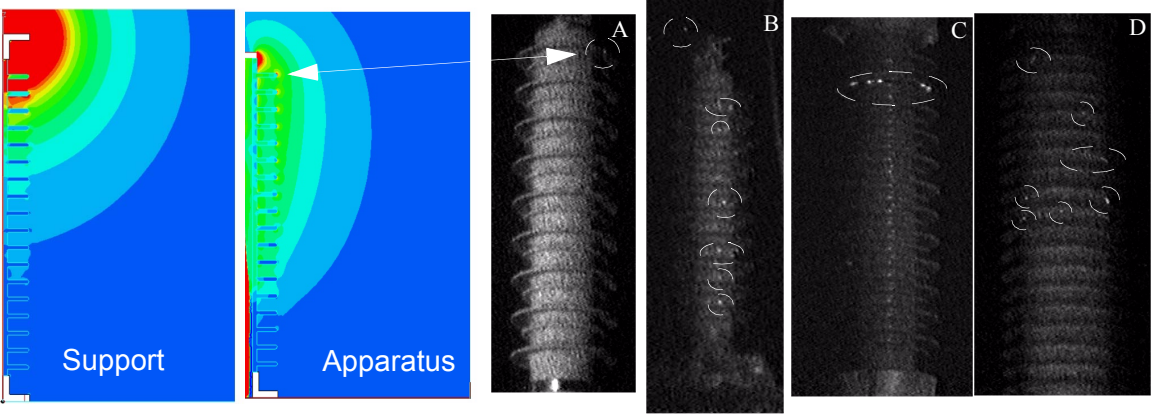
Figure 12 Apparatus insulators: examples of typical E-field and discharge activity concentration. A: arrester, silicone rubber, 12 mm/kV; B: arrester, silicone rubber, 23 mm/kV; C: hollow core, porcelain, 28 mm/kV; D: hollow core, silicone rubber, 23 mm/kV.

observed for hollow insulators of the same manufacturer. It seems that the speed of deterioration on hollow insulators is roughly 5 times lower (the beginning of deterioration in the form of traces of erosion observed on line insulators after 1 year in service was almost the same as observed on hollow insulators after 5 years in service at the same test station). This is also confirmed by almost no deterioration after 2-7 years of testing of apparatus silicone rubber insulators at Dungeness and Kelso. The most important explanation is a lower E-field in the vicinity of HV flanges in comparison with line insulators and different location of corona and discharge activity. Apart from the lower E-field stress and different location of its maximum for apparatus insulators, it is also possible that apparatus insulators collect less pollution than line insulators due to larger trunk diameter (this is well known for porcelain insulators) which also influences level of currents. For *line composite insulators* the initial water drop corona will be located at the vicinity of the sheath, reducing the hydrophobicity and making easier to create the next stage of discharge activity, i.e. dry band activity. This is illustrated by the results of night UV inspection of line insulators at Kelso station, see Figure 11. The diameter of the trunk for these insulators is very small (20-30 mm) and the density of the leakage current will be rather high. This can in long-term lead to the different levels of erosion obtained at line composite insulators at the discussed test sites. For *apparatus composite and porcelain insulators* the initial water drop corona will be located at the edges of the upper sheds and will not really influence the hydrophobicity, see results in Figure 12. When an insulator becomes polluted, the density of the leakage current will be lower than for the line insulator due to large diameter of the trunk (100 mm and more). It will be more complicated to create a dry band and sustain dry band discharge activity. In all cases, the location of dry bands will be randomly distributed along the insulator, as also shown in Figure 12.

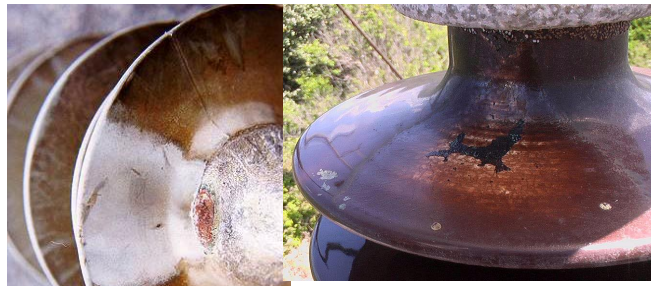
Figure 13 Kelso. Examples of line insulators flashed over due to pollution.

No flashovers were registered on any of the apparatus silicone rubber or porcelain insulators at all test stations during the whole exposure time. Some flashovers were however registered during the same exposure time on some hydrophilic (i.e. porcelain-like) line insulators at Kelso test station, see Table 4 and Figure 13.

Type of insulator	Specific creepage, mm/kV	Exposure time, years	Number of flashovers
Line EPDM	22	1	1
Longrod porcelain	28	6	7
Longrod porcelain greased <sup>a</sup>	28	6	7
Longrod porcelain RTV	28	6	0
Cap-and-pin glass	28	6	2
