Extreme maintenance

No location too challenging for an on-site repair!

The story begins in 2002 when an electric failure damaged one of the converter transformers installed at Foz do Iguacu. The required repair work entailed a complete replacement of the winding blocks.

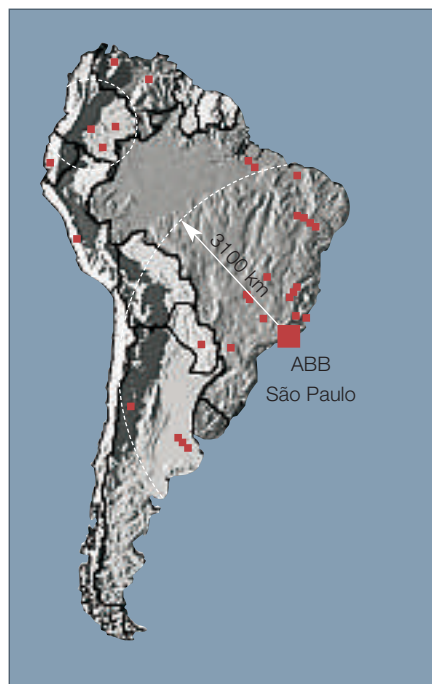
3

The substation at Foz do Iguaçu and its importance in the transmission system.

This on-site repair study is centered on the Itaipu Power Plant **3**. This is the largest hydro power plant in the world and is situated on the

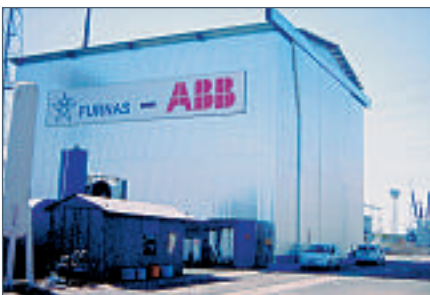
4

The metal house erected for on-site repair at Foz do Iguaçu.

In order to carry out such an on-site repair it is necessary to erect a repair facility with a solid foundation. In this case the metallic housing had an area of 500 m² and was 20 m high ⁴. It was erected on a spare transformer base. Environmental circumstances had to be taken into account: The repair facility was built to be able to withstand winds of 150 km/h and to remain watertight under heavy rainfall. Within the metal exterior, there was an internal extra-clean room. This provided a controlled environment for assembling the active part. The weight of the transformer's active part was approximately 180 tons and the lifting equipment used had a capacity of 400 tons ⁵.

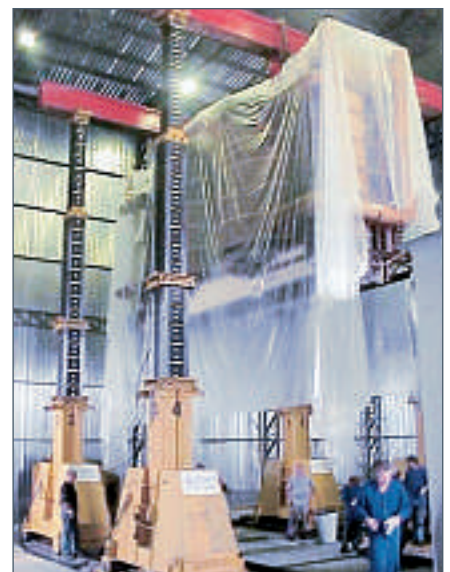
5

Lifting equipment inside the metal house.

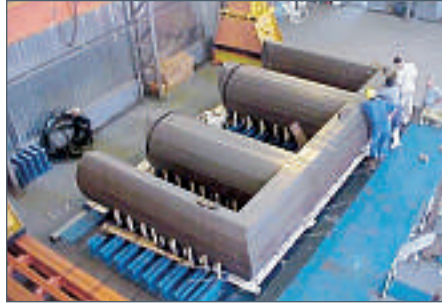
The repair was carried out including the replacement of the complete pressboard core insulation by fiberglass material. In order to retighten the core it had to be placed in a horizontal position. For this purpose a mobile core stack table capable of supporting 180 tons was constructed ⁶.
