ABB Test Technology ~ Engines

Short Block: Air Bearing Signature & Torque To Turn

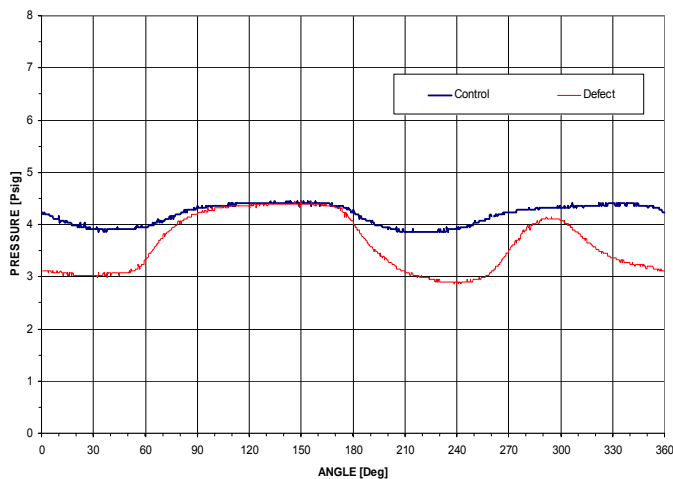
Plot 08 Missing Connecting Rod 2 Bottom Bearing
